BOILER ACCIDENT AT THE KURUNUI BATTERY, THAMES GOLD FIELD,

(ROYAL COMMISSION TO INQUIRE INTO THE, AND INTO THE MACHINERY AND BOILERS ON
THE FIELD GENERALLY).

REPORT.

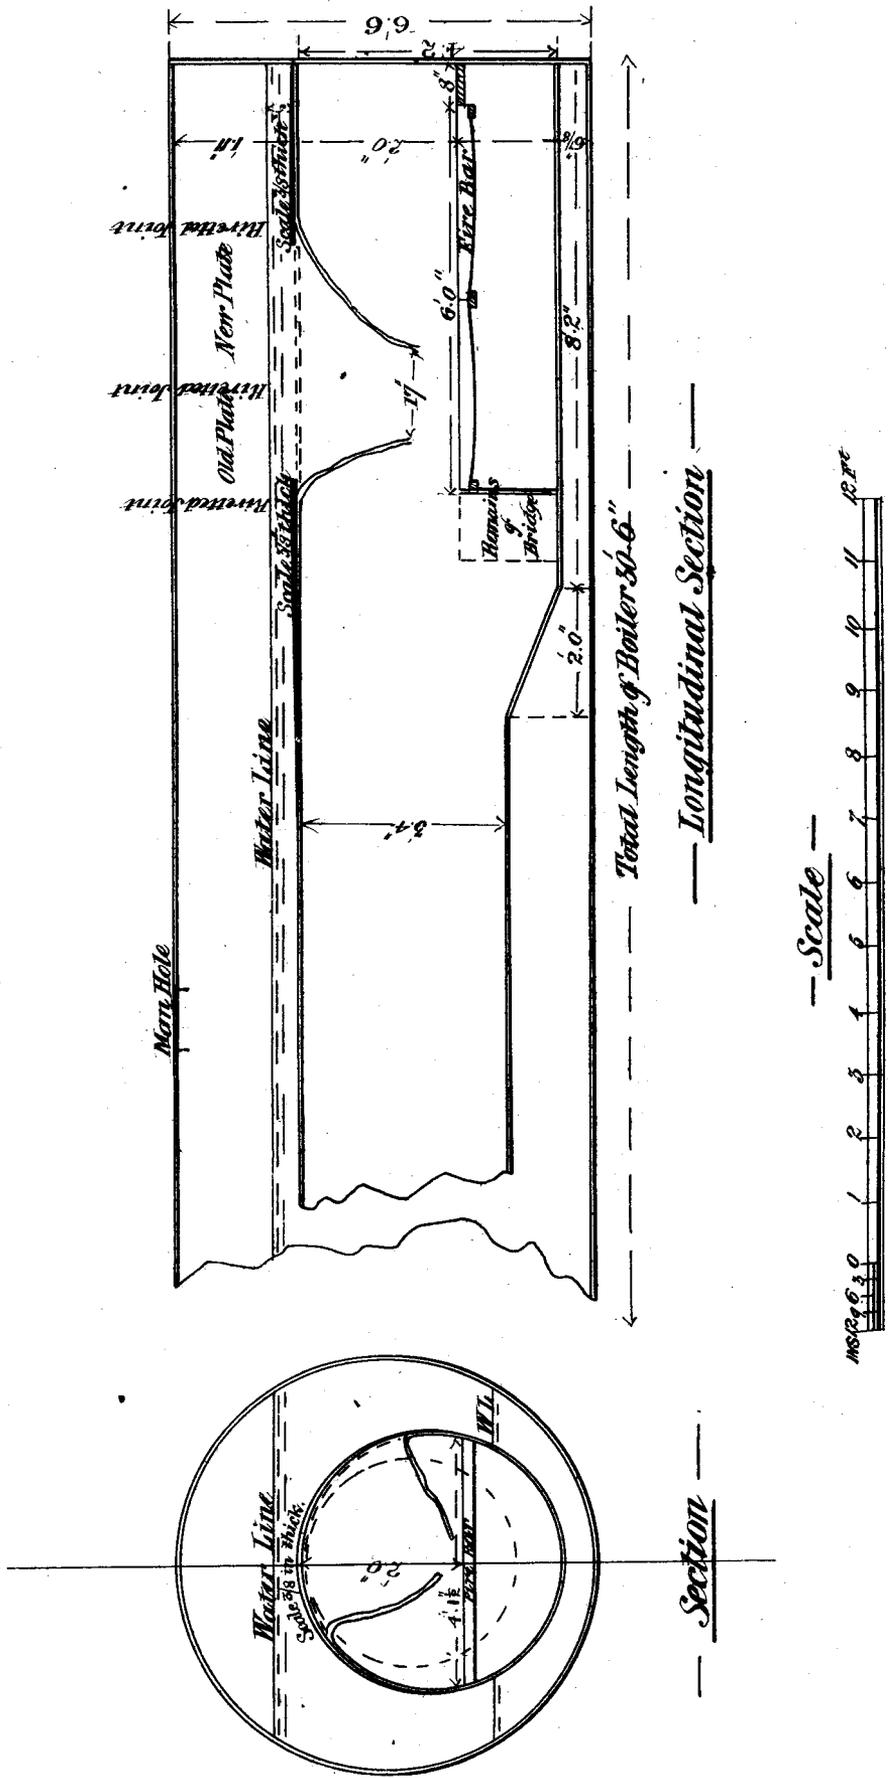
— Sectional sketch of Boiler after the accident —

The drawings appended show the form and dimensions of the boiler and the appearance of the ruptured plates.

The bursting took place by the collapse of the furnace, or the enlarged part of the flue; the plates of the crown tore away along two seams of rivets at right angles to each other, but otherwise the boiler was not damaged, nor was its setting in the brickwork disturbed in the least degree. The safety-valve was not moved, and was not out of working order, showing that it was not to any enormous increase of pressure that the bursting was due. The three unfortunate men who were killed had no duties which would take them to the boiler-house; they were in front of the boiler at the time, and were caught by the full force of the explosion. That this was not of a violent nature is proved by the reaction being insufficient to disturb the brick-setting, and were it not for the fatal results which followed, the accident in all probability would not have attracted much notice. But the cause of the explosion and circumstances leading to it are those surrounding many boilers, on the Thames Gold Field at least, and which, if not met with preventive measures, may at any time take effect; and from situation and surroundings be capable of equal or greater destruction to life and property.

The boiler had undergone repairs, and a new plate, one of those ruptured, had been put in the crown of the furnace, after which it had been at work for only five days when the collapse took place. The usual time for working each boiler before cleaning was four or five weeks. The steaming is continuous, day and night, Sundays excepted. Three firemen are engaged, each taking a shift of eight hours. The machinery and boilers are under the charge of one engineer. From the circumstances that two of the firemen have tended this boiler from the first starting of the battery, and the third almost as long, and all are, according to the testimony of the Company's mine manager and others, "perfectly steady and regular in their duties," the collapse of the boiler five days after being repaired certainly seems remarkable. But the cause of the accident is very evident to your Commissioners, and is plainly stated by nearly all the witnesses. The shaded portion of the drawings over the flue denotes an incrustation of nearly pure salt, which overspread the crown of the furnace exactly where the heat takes most effect. The position of the rupture is just where the heat would impinge on the crown with greatest intensity; and there the thickness of the salt scale was $\frac{1}{8}$ of an inch, forming a non-conducting material sufficient to cause the plates to become hot, thus losing their strength, and hence the collapse. This result was most likely accelerated by the non-conducting scale, as it formed, impeding the evaporating power of the boiler, thus causing the fires to be forced in some degree, in order to keep up steam. The draught of that furnace is stated to be intense, and under the circumstances it would be the work of a very few minutes to heat the crown to redness. The plate put in during the repairs mentioned was of rather a laminated nature; scales $\frac{1}{4}$ th of an inch thick were taken off it after the rupture. Those present an appearance of having been red hot, and had parted from the body of the plate. An area estimated at 80 square inches was thus left at, according to the laws of the strength of such flues, of less than half the strength the original thickness of $\frac{3}{8}$ ths of an inch. The area of this was too small, however, to seriously damage the strength of the flue, had the iron remained free from incrustation. The flue is, as we have stated, an unusually large one—50 inches in diameter. It is true, its length at this size is only 8 feet, being tapered in, with a flush crown, to 40 inches diameter at 10 feet from the front end. The full length is 30 feet 6 inches, and no stay rings were originally on it. Taking the most favourable view of this flue, its ultimate strength, when new, was, on the data of 30 feet long, 40 inches diameter, and $\frac{3}{8}$ ths of an inch thick, 96 lbs. per square inch. And the consequence of the furnace end being, for a length of 8 feet, 50 inches in diameter, must have been to reduce to some extent, not easily determined, the above not very great collapsing pressure. Then as to the pressure at which it was worked. The engineer and firemen say 25 lbs. to 30 lbs., but the valve was set to 37 lbs. per square inch, according to the data furnished by the Mining Inspector in his evidence. This pressure is $\frac{1}{8}$ of the ultimate resistance, and an absurdly low factor of safety. The safety-valve was seen by Kay, the fireman on duty, just before the accident, to be slightly blowing off; and it must be very evident that a flue worked at so very small a margin of safety, if indeed such a term can be applied at all, would require but very small amount of weakening to insure the destruction which eventually happened. All the evidence points to sufficient water being in the boiler, and there is no reason for doubt on this point.

The incrustation, then, we are assured, was the immediate cause of the collapse; and we have as little doubt that the incrustation was only the effect of undue saltiness of the water in the boiler. This even those in immediate charge admit, although they state that they are unable to account for it. But the fact is incontestable, in our opinion; and a careful study of the evidence, and an actual testing of the salinometer in use, together with calculations relating to the evaporation, feed, and blow-off of the boiler, lead, not to wonder that the salting took place, but to astonishment that it did not work its effect long ago.

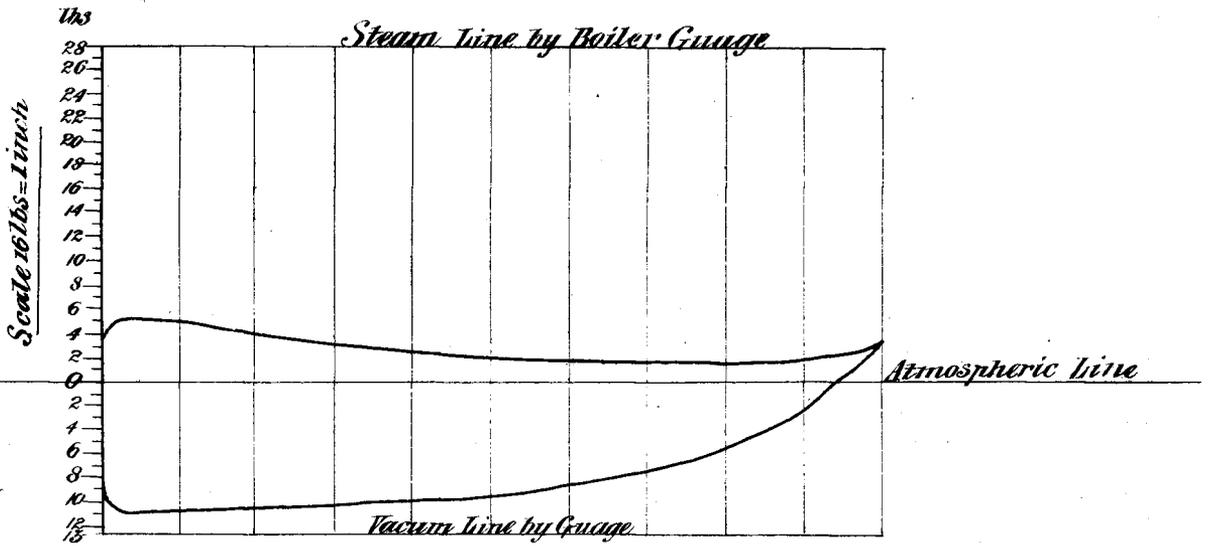
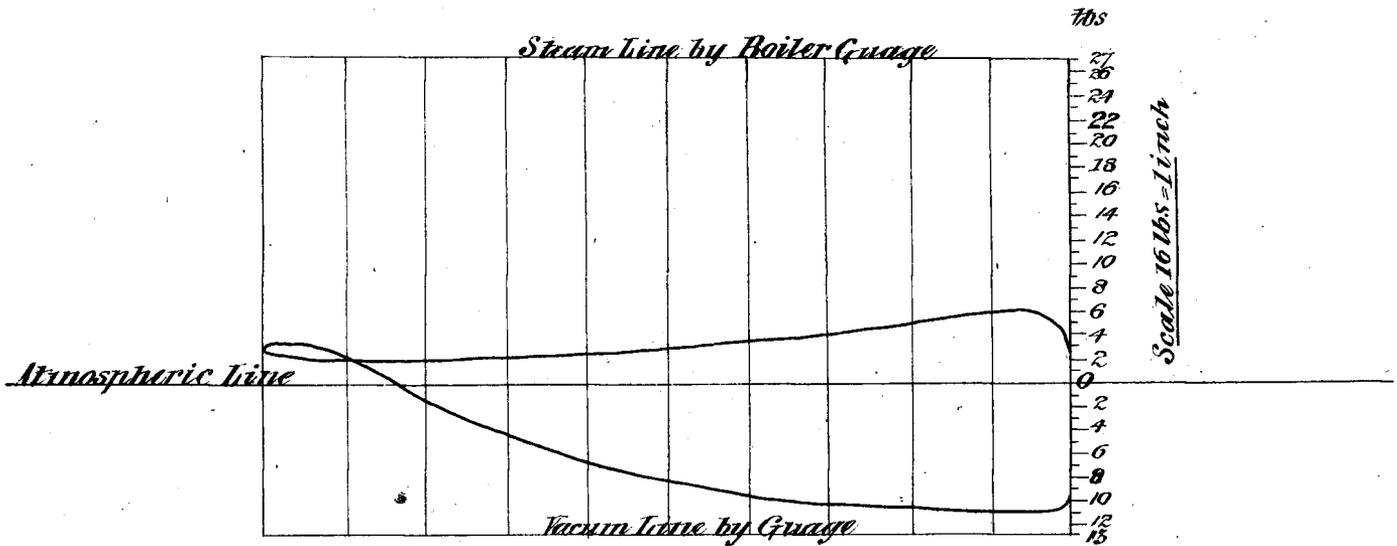
ENGINE DIAGRAMS KURANUI BATTERY

Indicating 37.2 HP

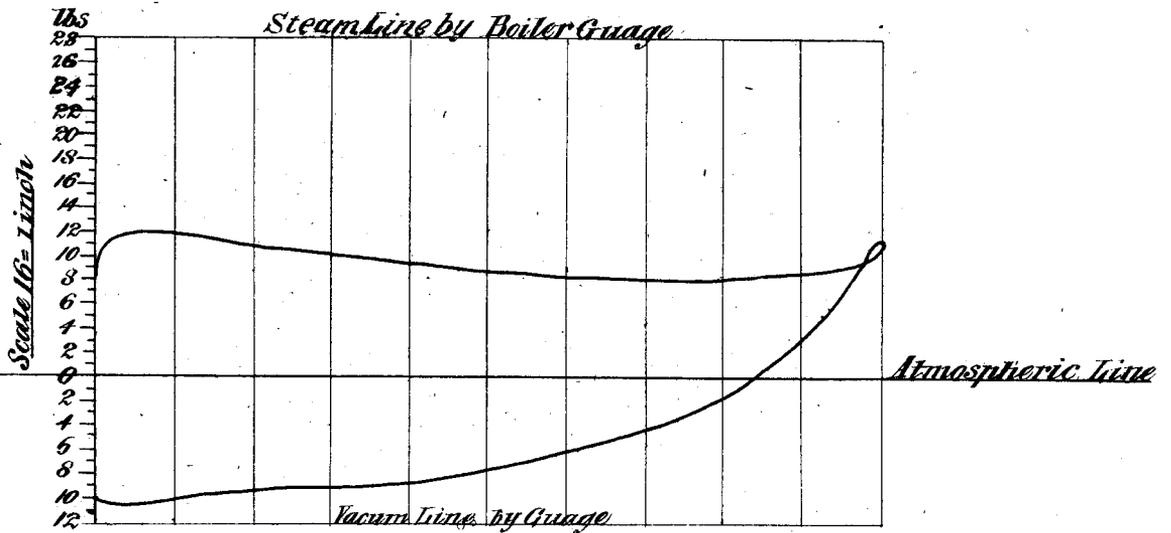
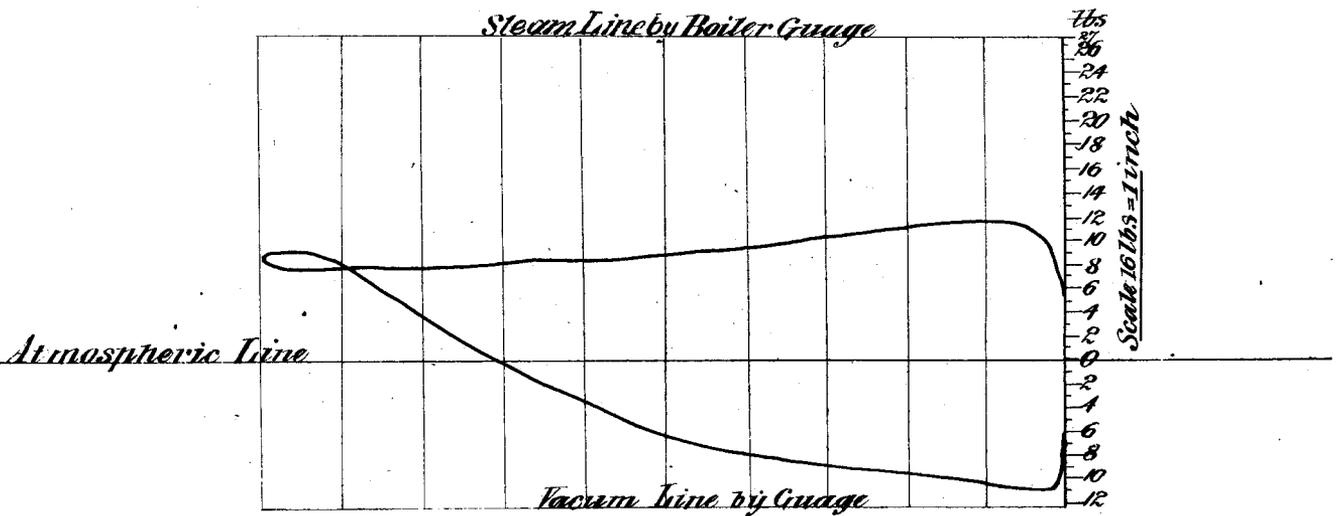
— ENGINE DIAGRAMS. KURANUI BATTERY —

Indicating 56 HP
